DEPARTMENT OF TRANSPORTATION**DIVISION OF ENGINEERING SERVICES**

Contract #: 04-0120F4Cty: SF/ALA Rte: 80 PM: 13.2/13.9File #: 69.28**WELDING INSPECTION REPORT****Resident Engineer:** Pursell, Gary**Address:** 333 Burma Road**City:** Oakland, CA 94607**Report No:** WIR-001920**Date Inspected:** 04-Apr-2008**Project Name:** SAS Superstructure**OSM Arrival Time:** 1800**Prime Contractor:** American Bridge/Fluor Enterprises, a JV**OSM Departure Time:** 730**Contractor:** Zhenhua Port Machinery Company, Ltd (ZPMC), Changxing Island **Location:** Shanghai, China**CWI Name:** Chen Xi**CWI Present:** Yes No**Inspected CWI report:** Yes No N/A**Rod Oven in Use:** Yes No N/A**Electrode to specification:** Yes No N/A**Weld Procedures Followed:** Yes No N/A**Qualified Welders:** Yes No N/A**Verified Joint Fit-up:** Yes No N/A**Approved Drawings:** Yes No N/A**Approved WPS:** Yes No N/A**Delayed / Cancelled:** Yes No N/A**Bridge No:** 34-0006**Component:** OBG**Summary of Items Observed:**

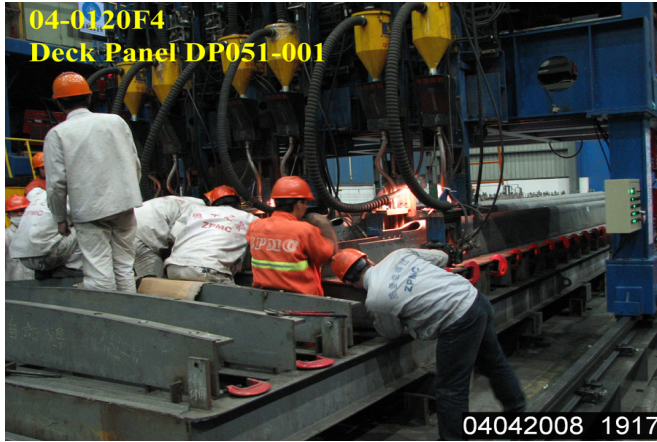
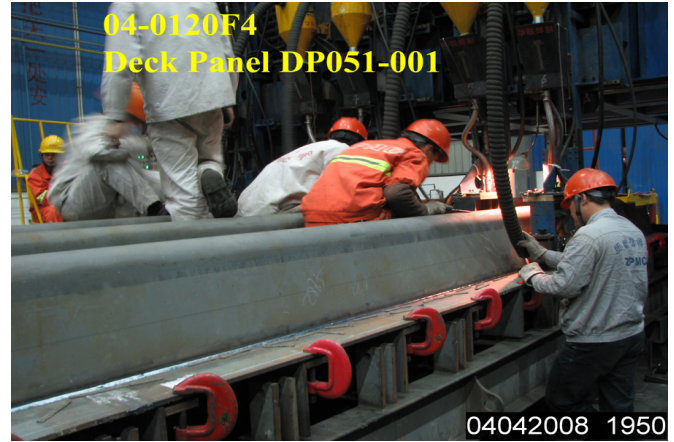
Item Description	WBS	Dwg No.	Status
1 Deck Panel	NA	NA	QA UT
Storage Yard Outside New OBG Fabrication Bays - Caltrans QA Inspector performed Ultrasonic Test (UT) inspection of the partial joint penetration (PJP) welds joining closed u-ribs to deck panel. The deck panel is identified as DP488-001. Caltrans QA performed QA verification UT inspection on 15% of the full length of welds which have been previously UT inspected by ZPMC QC inspection personnel on the following weld joints: DP488-001-001, DP488-001-002, DP488-001-003, DP488-001-004, DP488-001-005 and DP488-001-006. See Caltrans ultrasonic testing report (TL-6027 Modified) dated April 04, 2008 for further information.			
2 Deck Panel	NA	NA	Welding
OBG Bay 1-Production Monitoring Deck Panel DP051-001- Caltrans QA Inspector observed submerged arc welding (SAW) in progress, closed u-rib sequence welding of welds 001 & 002, u-rib 111, welds 005 & 006, u-rib 114 and welds 009 & 010, u-rib 140. The SAW is being performed at Gantry 1. See Caltrans production deck panel welding record, which is being maintained on file at the on site OSM office for further information. The following digital photographs illustrate welding in progress at the work-station.
